John and Jane Doe
1234 E. Some Place
Anywhere, AZ

RE: Engineering Evaluation, Distress Cracks on Interior Floor Tiles and Slab
1234 E. Some Place
Anywhere, AZ

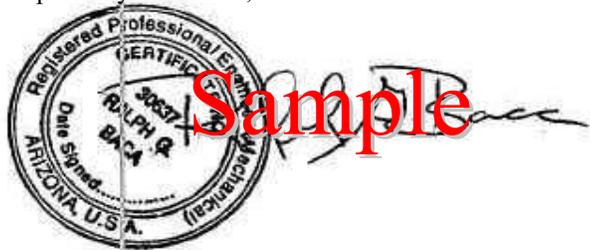
Ralph G. Baca, P.E.
Principal Engineer

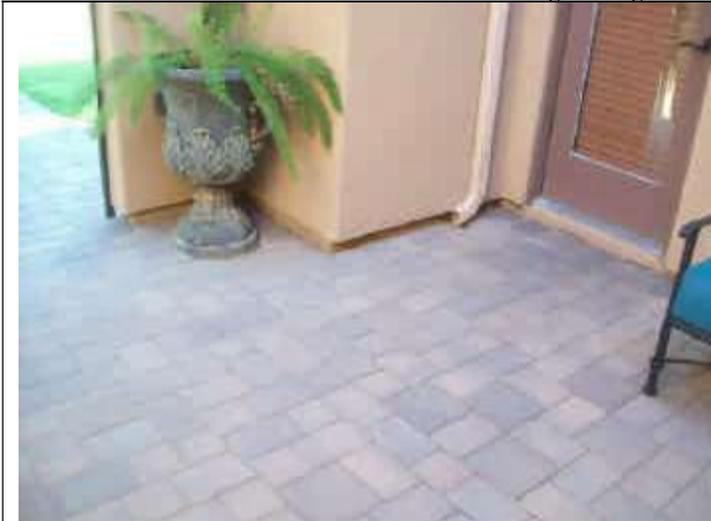
Photo 1: Front porch downspouts drain to west end porch and along guest room stem wall areas.

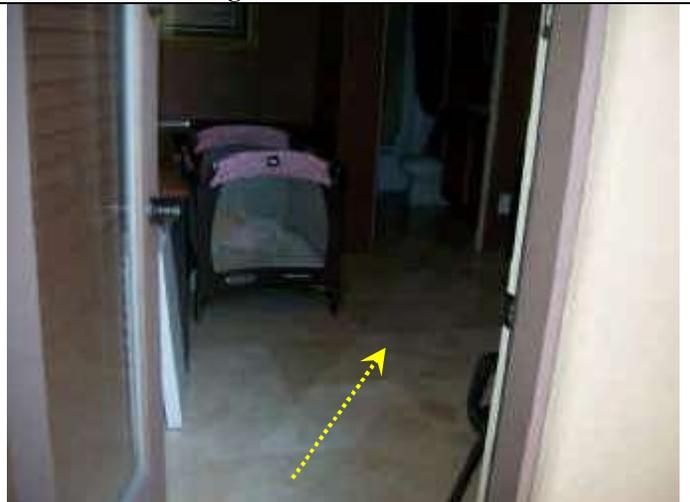
Photo 4: View looking west into guest room. Distress crack on floor tiles running diagonally through room.

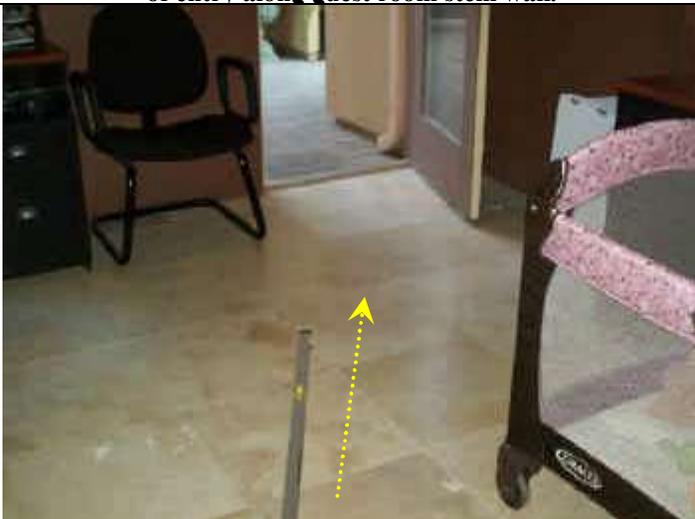
Photo 5: View looking east from guest room. Distress crack on floor tiles running diagonally through room.

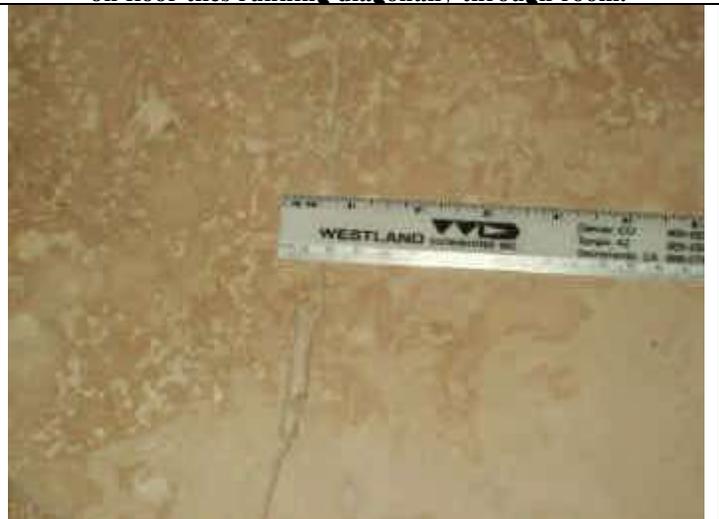
Photo 6: Cracks measured at less than 1/16th inch in width with no vertical displacement in guest room.

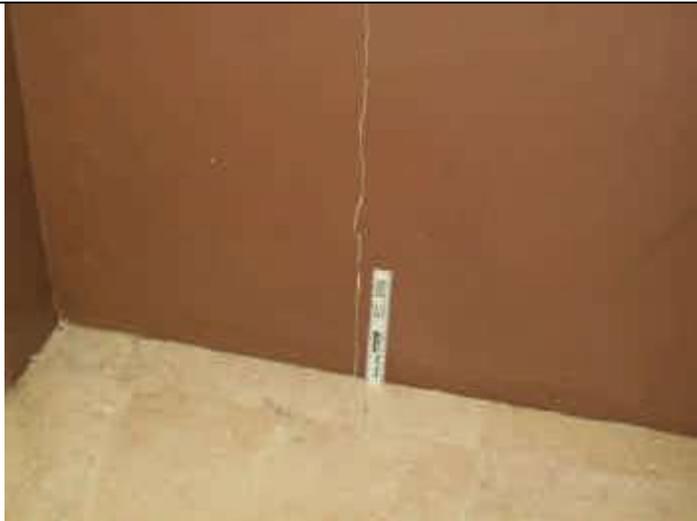
Photo 7: Hairline cracks on drywall of south wall of guest room.

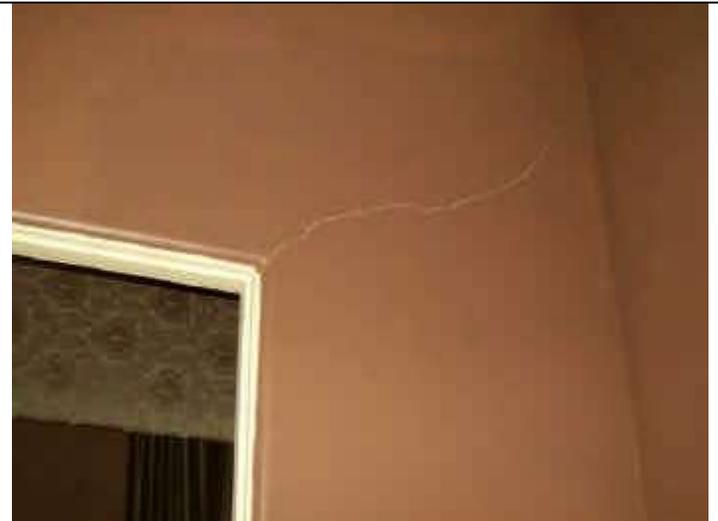
Photo 8: Hairline cracks on drywall at corner of interior door of guest room.

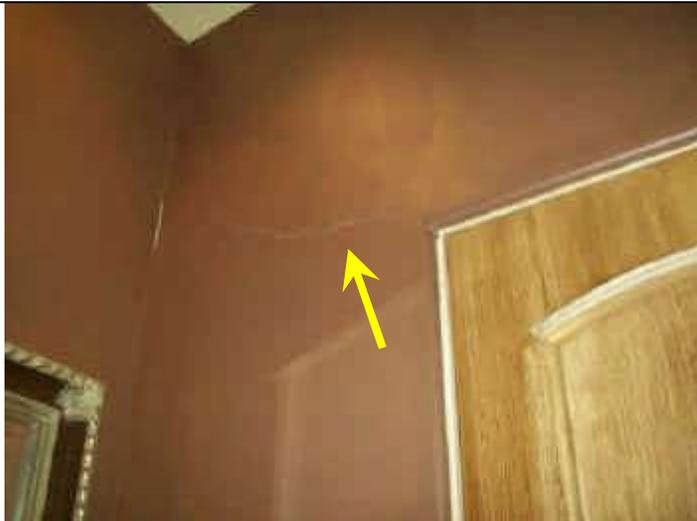
Photo 9: Hairline cracks on drywall at corner of entry door of guest room.

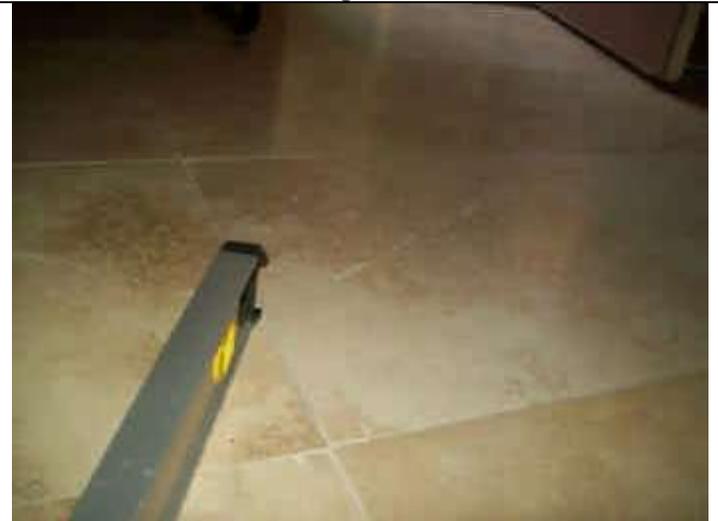
Photo 10: View looking east from guest room. Distress crack on floor tiles running diagonally through room.

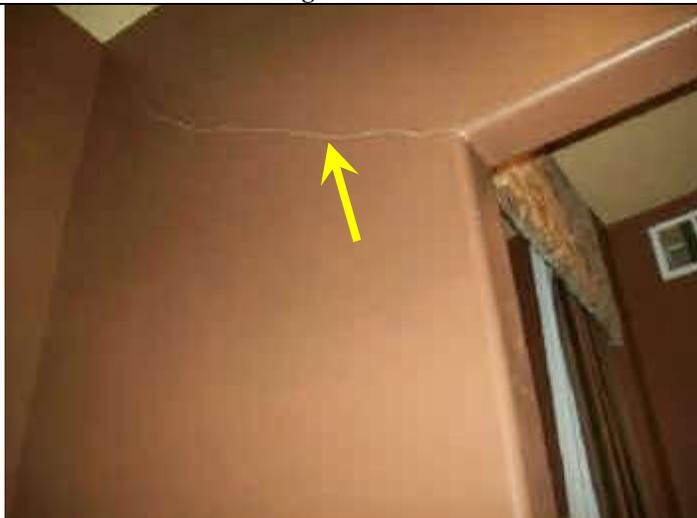
Photo 11: Hairline cracks on drywall at corner of interior door of guest room.

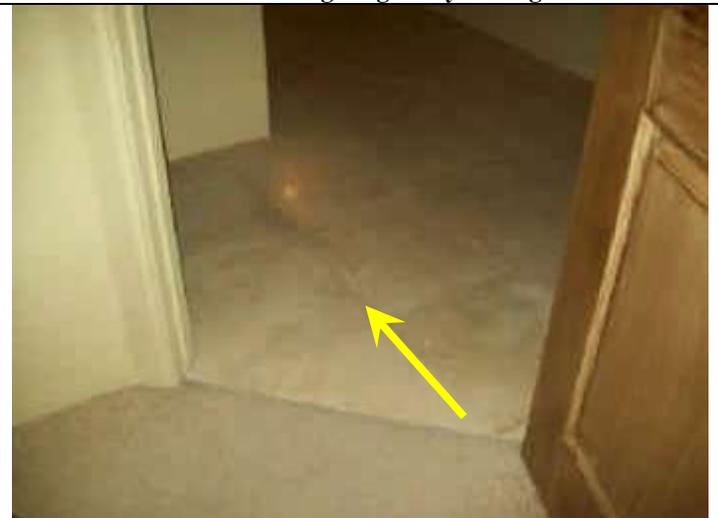
Photo 12: View looking down hallway in main home. Distress crack on floor tiles at entry to bedroom.

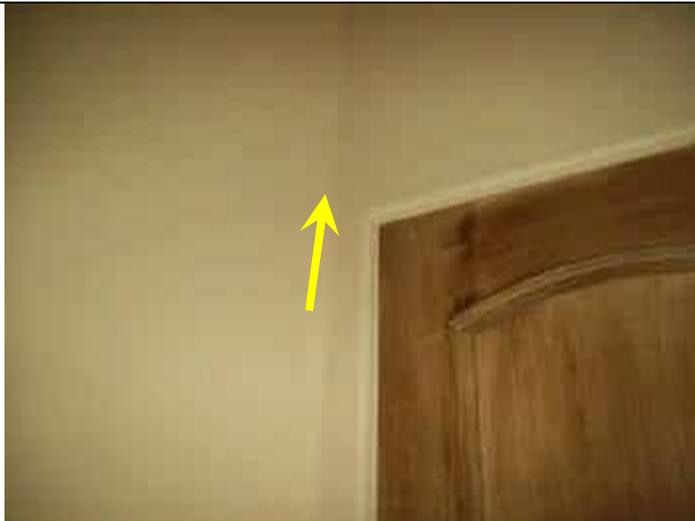
Photo 13: Hairline cracks on drywall at corner of interior door of bedroom.

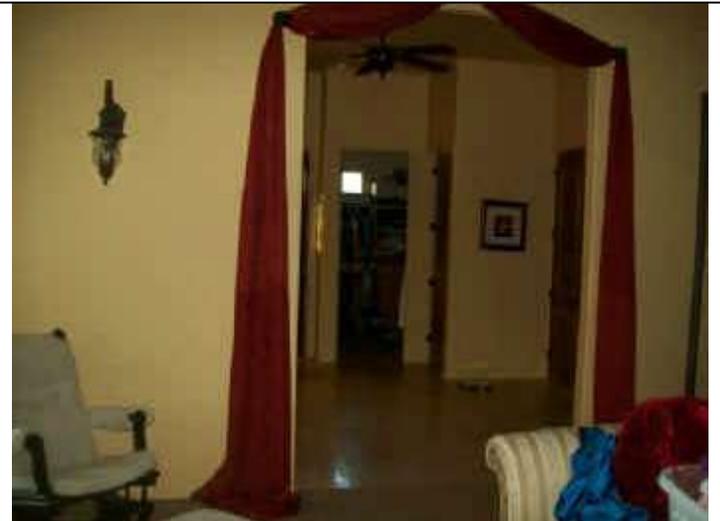
Photo 14: View looking north into master bedroom. Uneven flooring of carpet at entry to bathroom area.

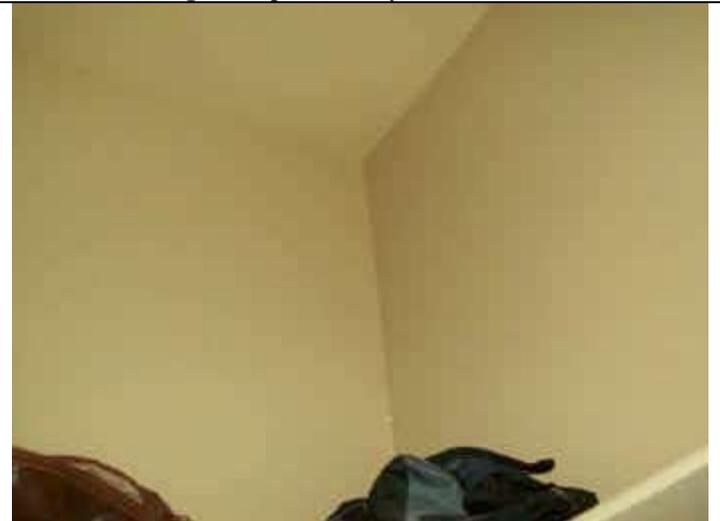
Photo 16: Distress crack in drywall of MBR closet area.

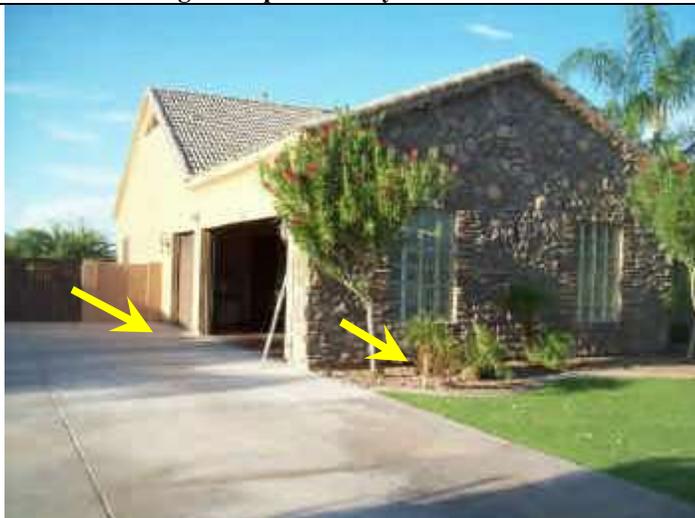
Photo 17: Front exterior view west end of home. Negative grade along garage south and west ends.

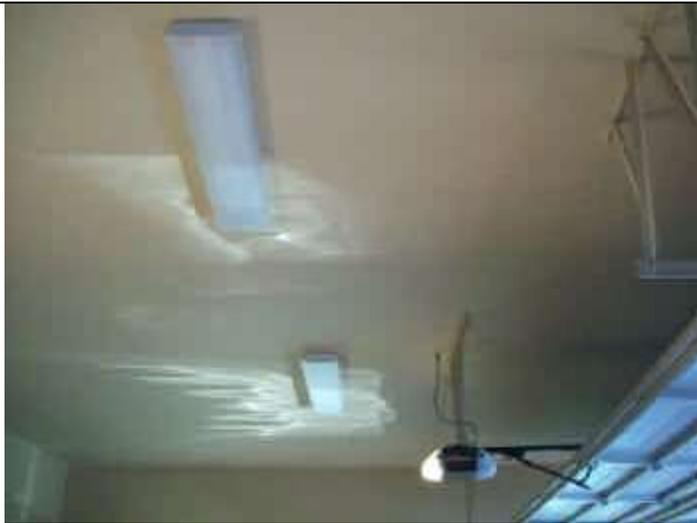
Photo 19: Distress crack on garage ceiling drywall.

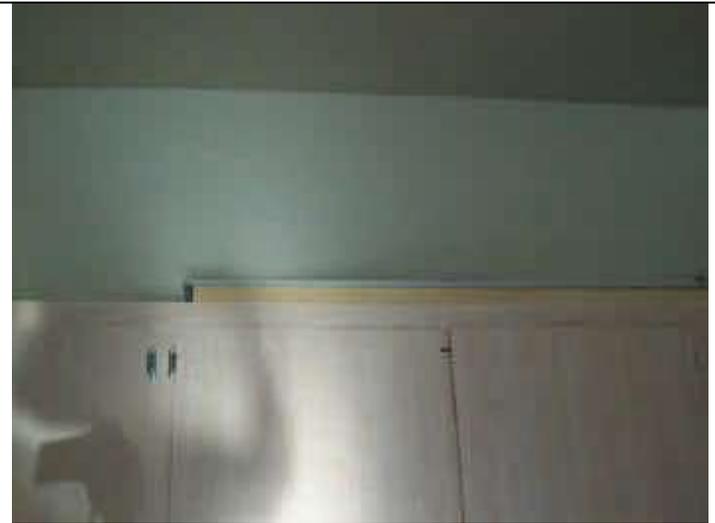
Photo 20: Distress crack on garage wall drywall above cabinets. .

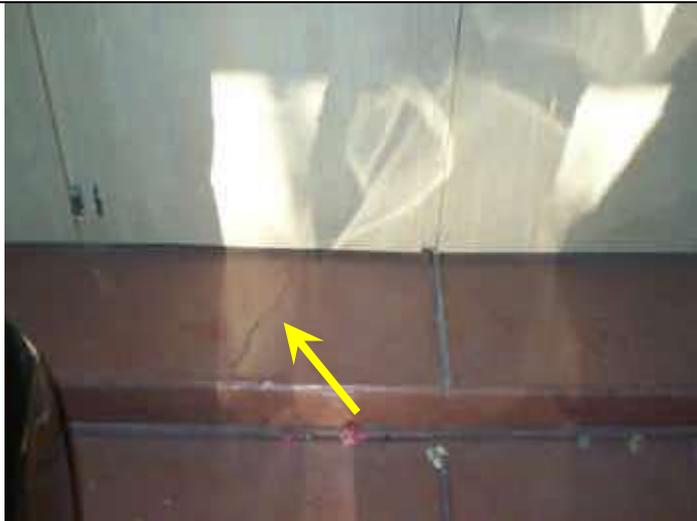
Photo 21: Distress crack on garage concrete at step up along east edge.

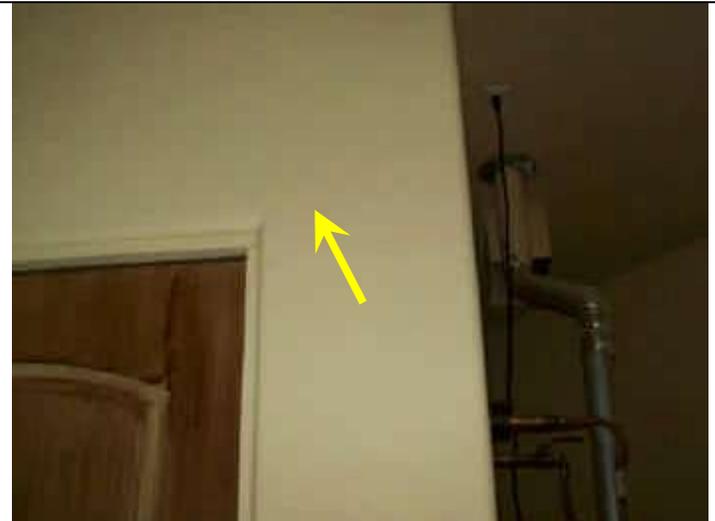
Photo 22: Distress crack on garage wall drywall above entry door. .

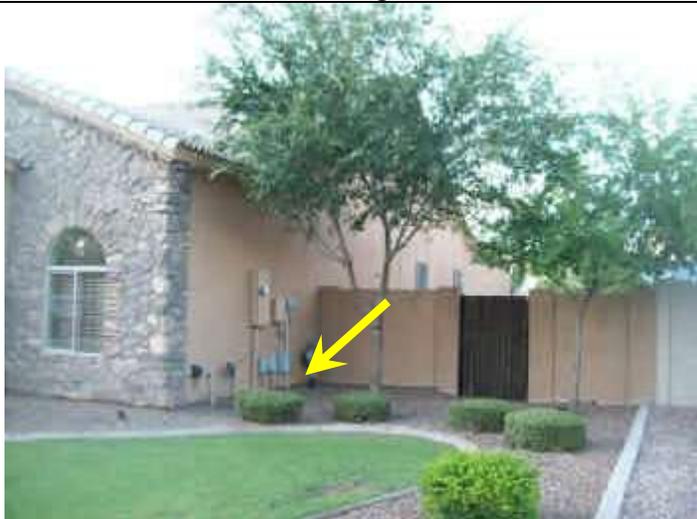
Photo 23: Front exterior view east end. Low spot and negative grade at utility entrances.

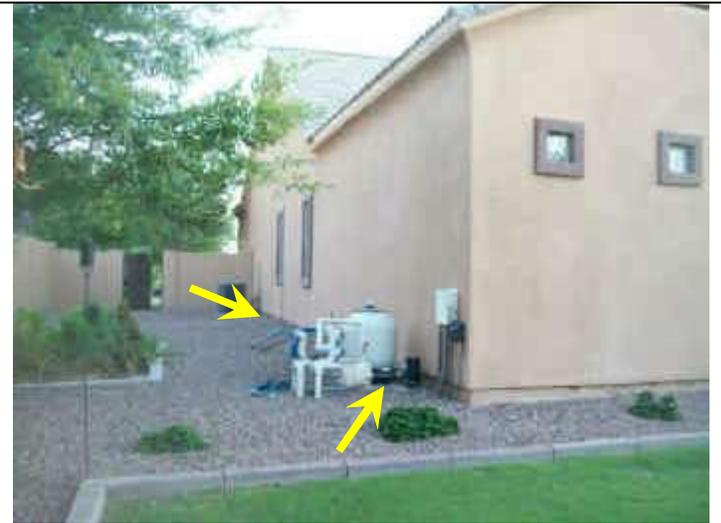
Photo 26: Rear exterior view east end. Low spot and negative grade. Signs of previous pool pump repair north end.

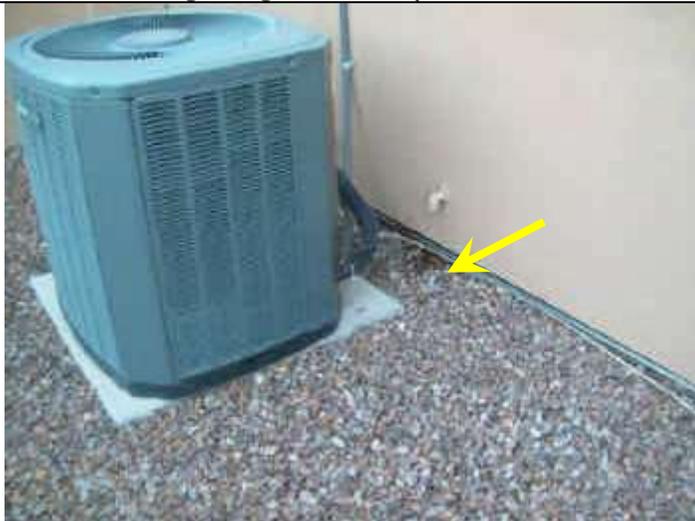
Photo 27: AC condensation line drains to east stem wall.

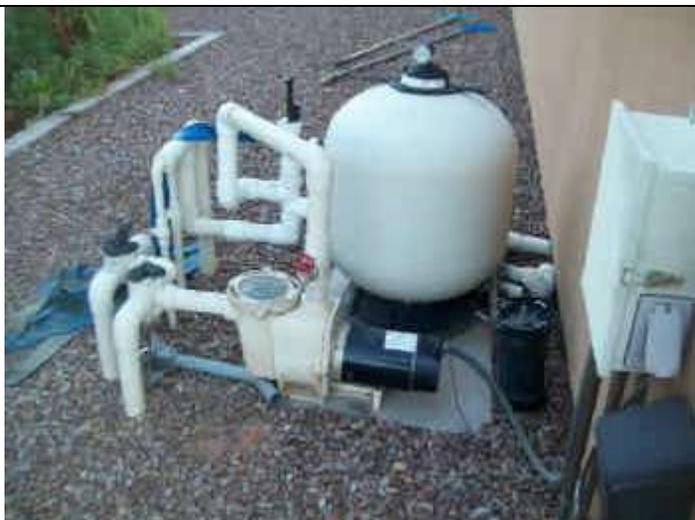
Photo 29: Rear exterior view east end. Signs of previous pool pump repair north end.

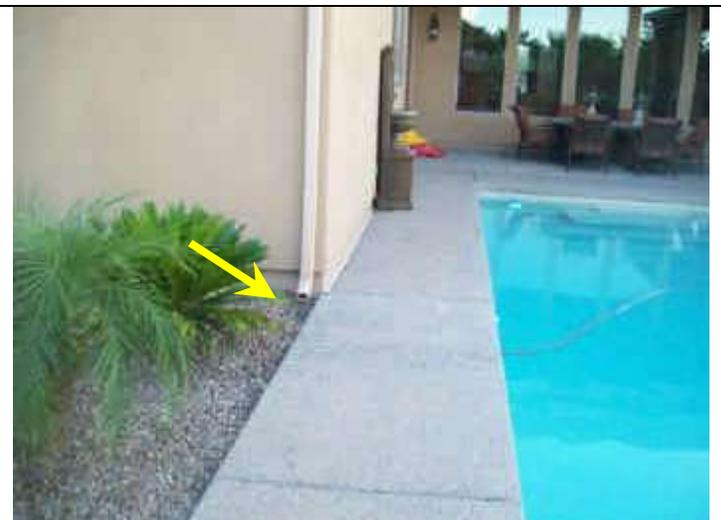
Photo 30: Downspout drains to rear exterior stem wall.

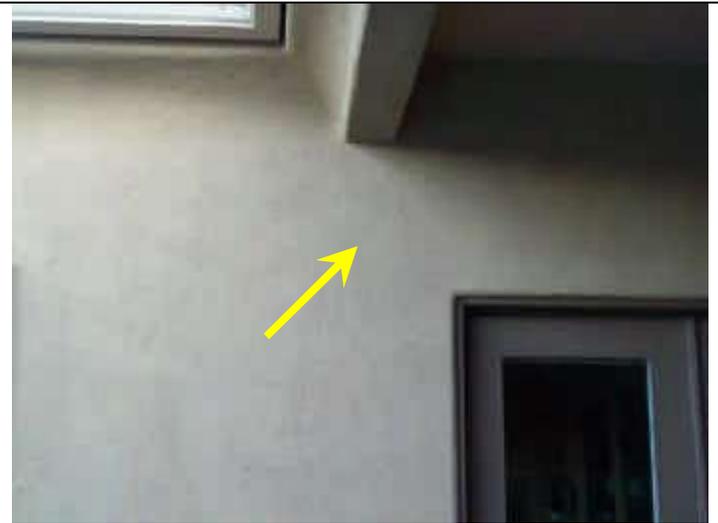
Photo 32: Distress crack on rear exterior stucco surface.

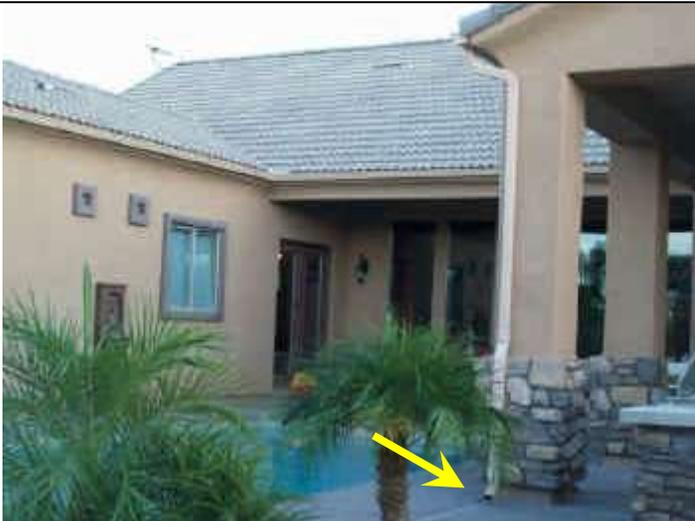
Photo 33: Rear exterior view. Downspout drains to patio column support.

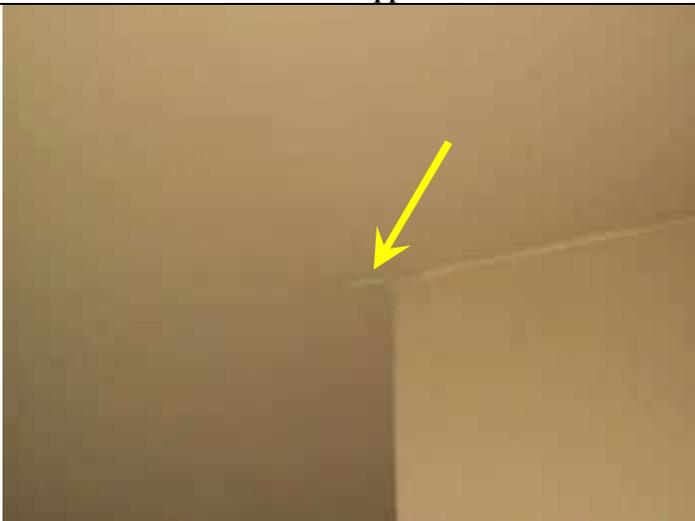
Photo 35: Distress crack on rear patio ceiling drywall.

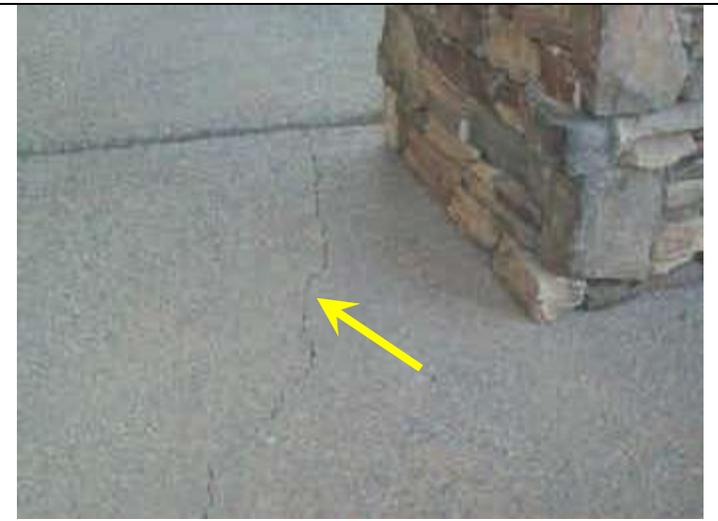
Photo 36: Distress crack on rear patio concrete slab.

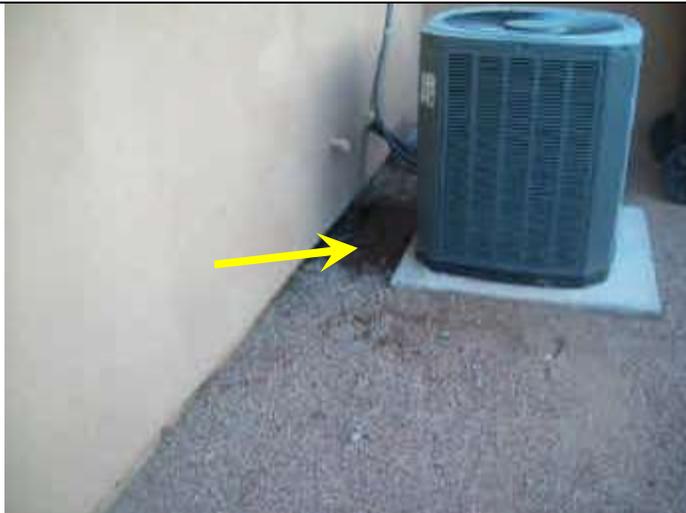
Photo 37: AC condensation line drains to stem wall along west exterior.

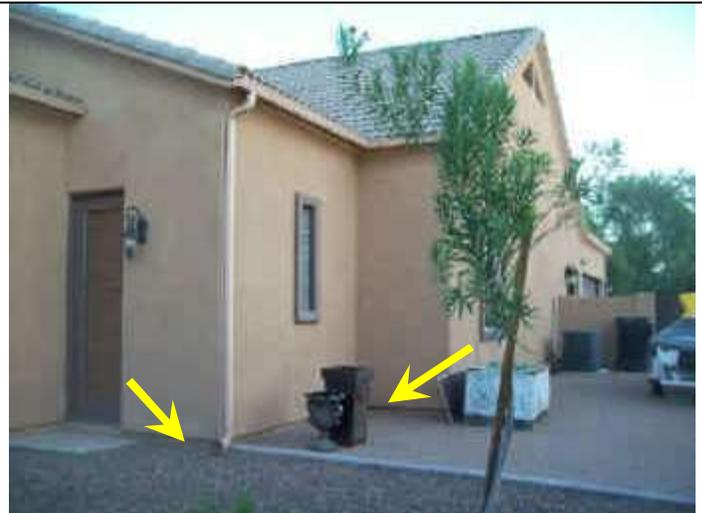
Photo 38: West exterior view. Downspout drains to stem wall and low spots noted along stem wall.

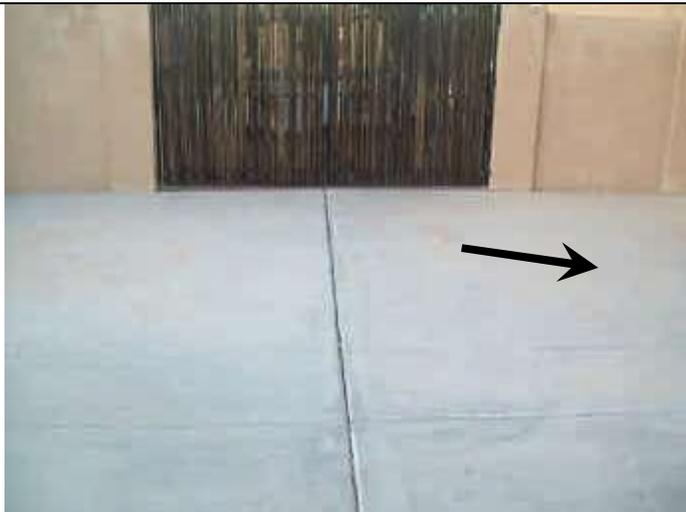
Photo 39: West driveway slopes to main home.
